Manhole Inspection Summary

Manhole # S13EE2031MH

Location Address: **2114 WESTERN RUN DR** Cross Street: **EASTCLIFF DR**

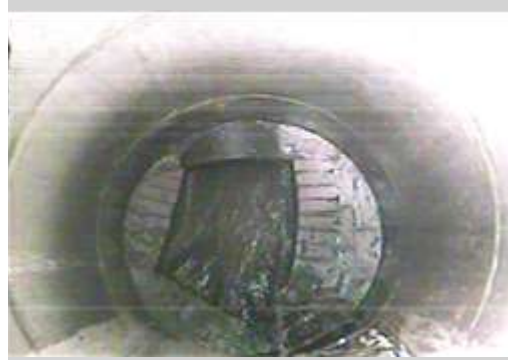
Top View

Corbel and Barrel infiltration. Corroded steps. Evidence of surcharge - Bench debris.

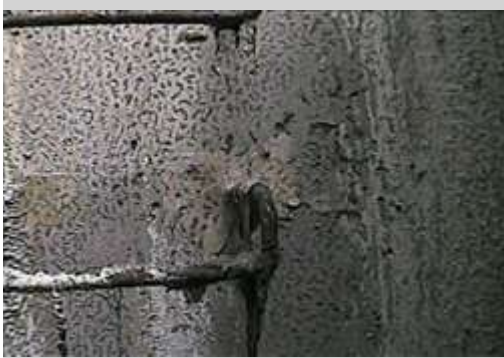
Evidence of surcharge

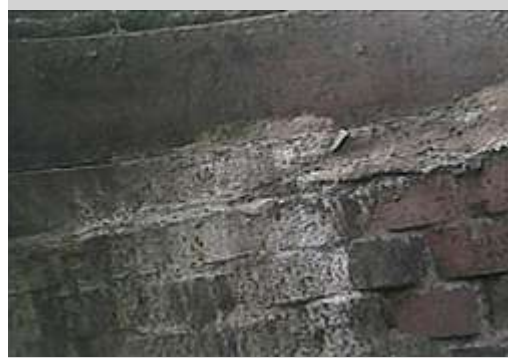
Defect

Frame leaks. Adjustment infiltration.

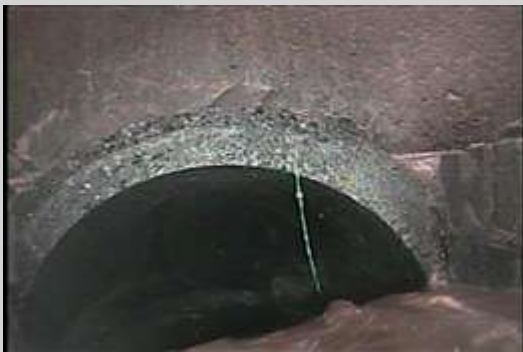
21 in. Circular Gravity Sewer Pipe Out @ 12 O'Clock

Infiltration: **None** Pipe Seal Cond: **Unknown**

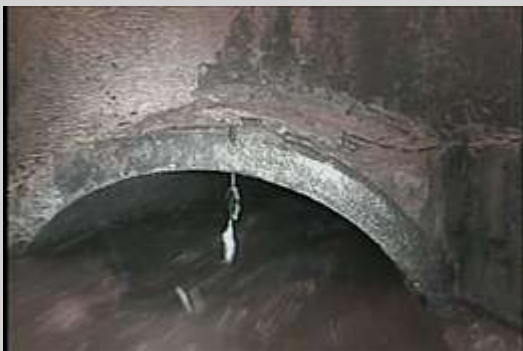
21 in. Circular Gravity Sewer Pipe In @ 7 O'Clock

Infiltration: **Evidence** Pipe Seal Cond: **Unknown**
